# Navajo Abandoned Uranium Mine

## Site Screen Report

**Mine Name: Kasewood Bahe No. 1  
Mine ID: 88**

**August 2011**

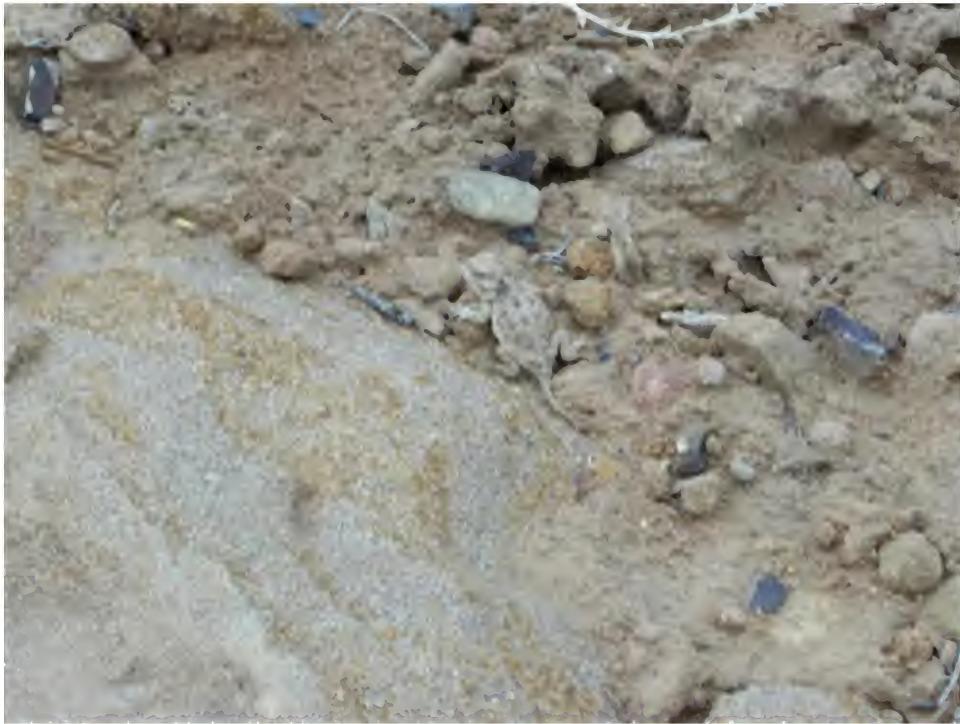
**Photo 3:** Mine Site #88; Wildlife

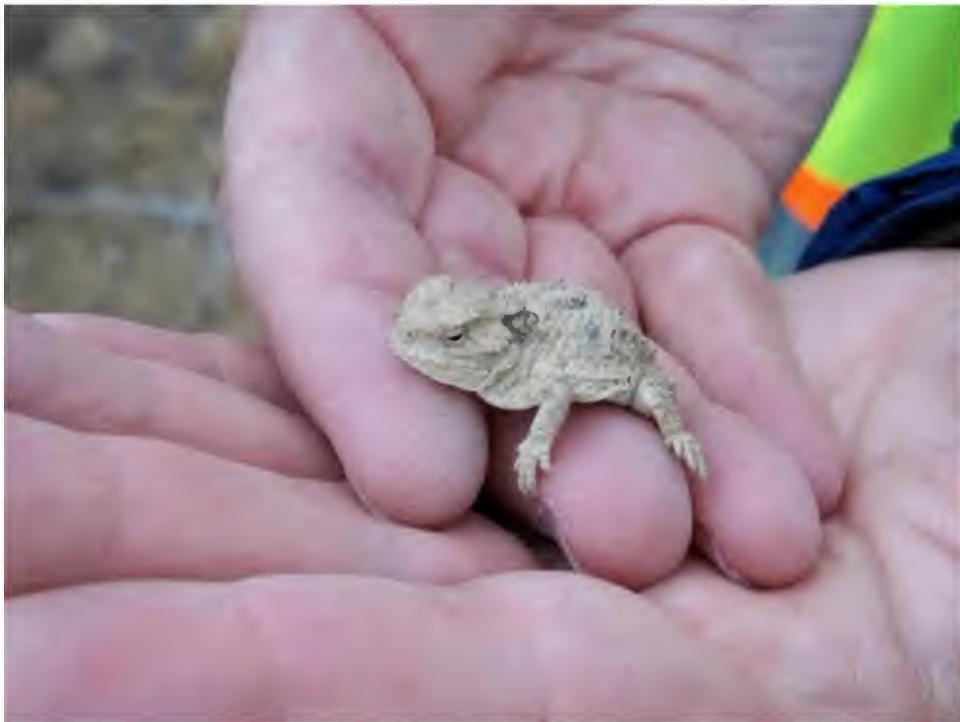
**Photo 4:** Mine Site #88; Wildlife

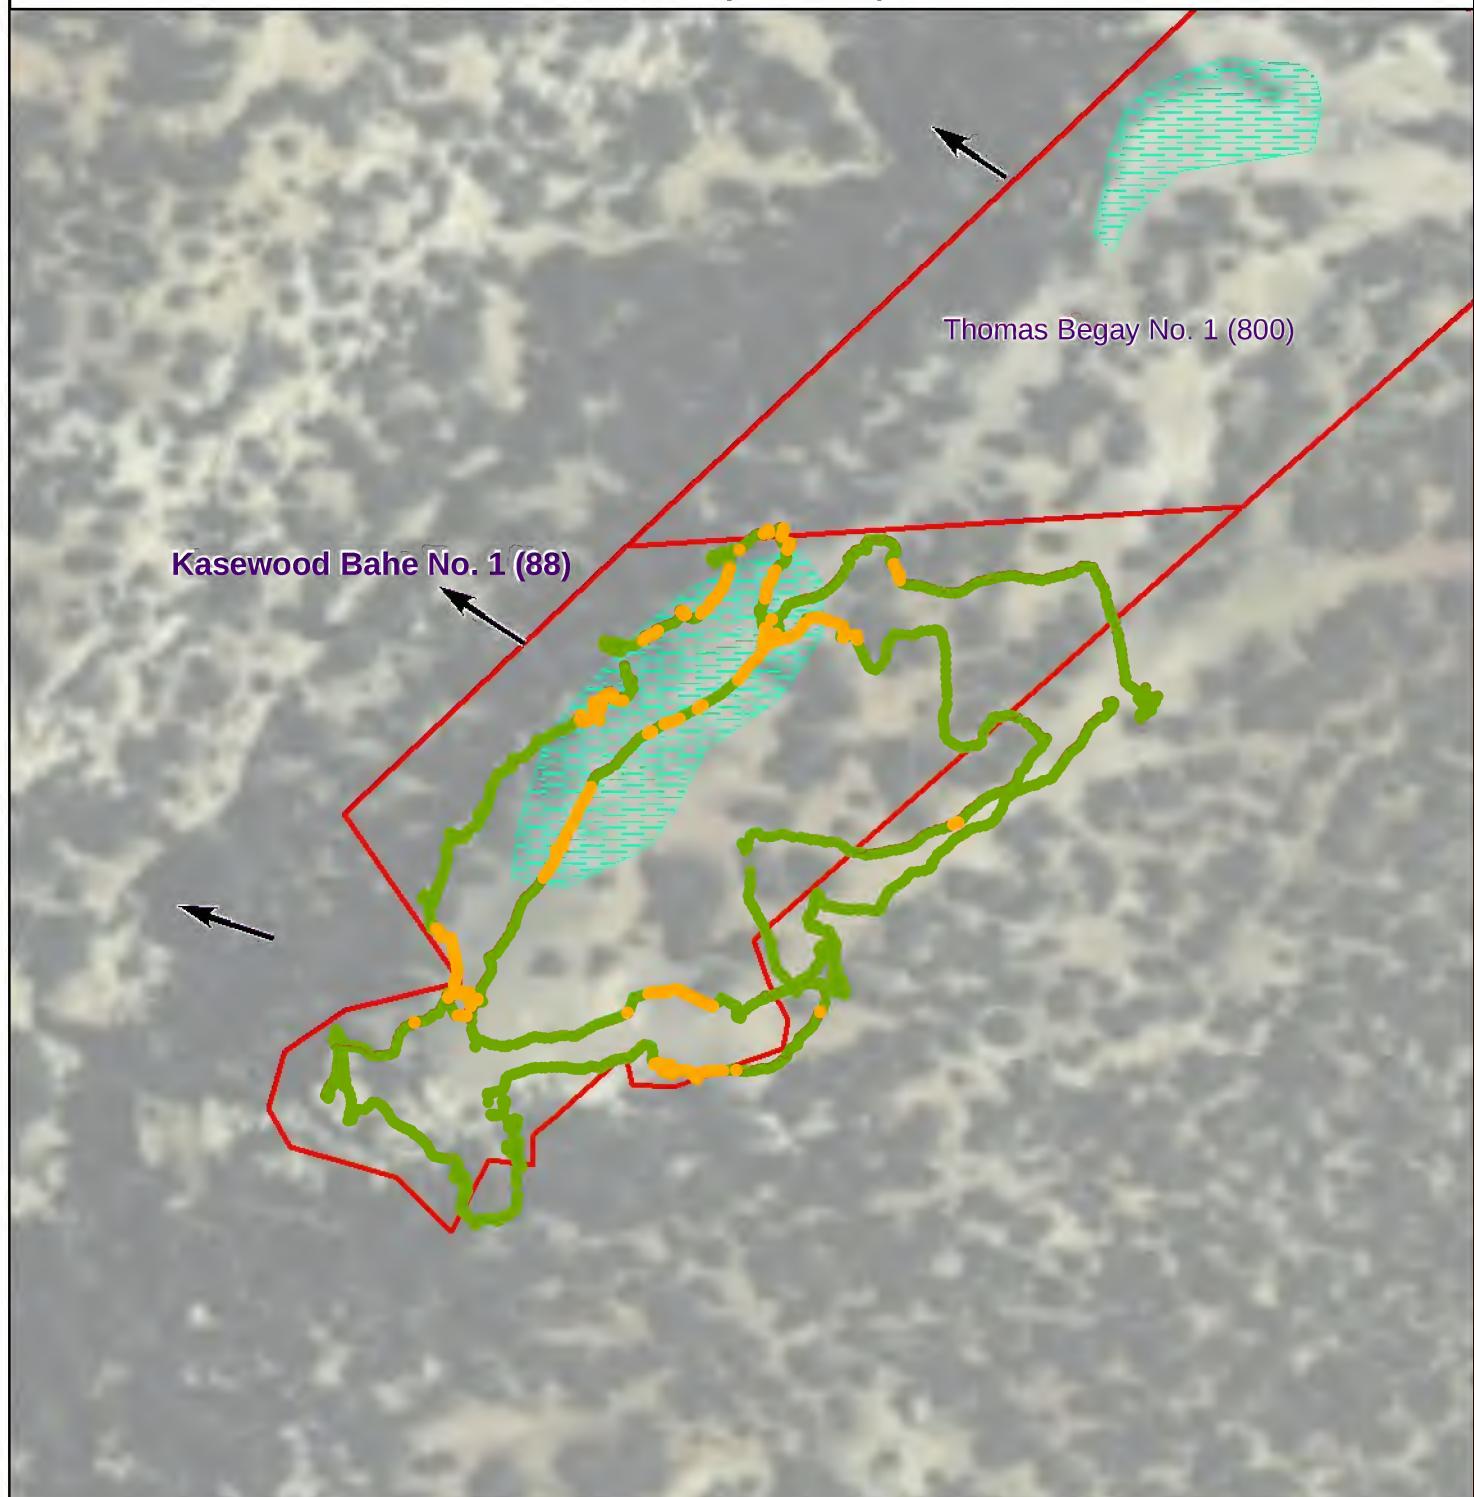
**Figure 1 - Gamma Radiation Measurements, Above Two Times Background**  
**Kasewood Bahe No. 1 (88)**  
**Black Mesa Chapter, Navajo Nation**

A total of 2,255 gamma radiation measurements were collected from the mine site, ranging from 12,103 cpm to 135,084 cpm. Measurements collected in the vicinity of the reclamation area were found at a maximum level of approximately 135,000 cpm. The measurements are represented in Figures 1 and 2.
